**Upper Ash Pond Dam
– A.B. Brown Station
Assessment Report**

Lockheed Martin

July 2009

This report addresses the above issues for the Upper Ash Pond Management Unit at the A.B. Brown Generating Station in Evansville, Indiana . This Southern Indiana Gas & Electric power generation facility is owned and operated by Vectren Power Supply.

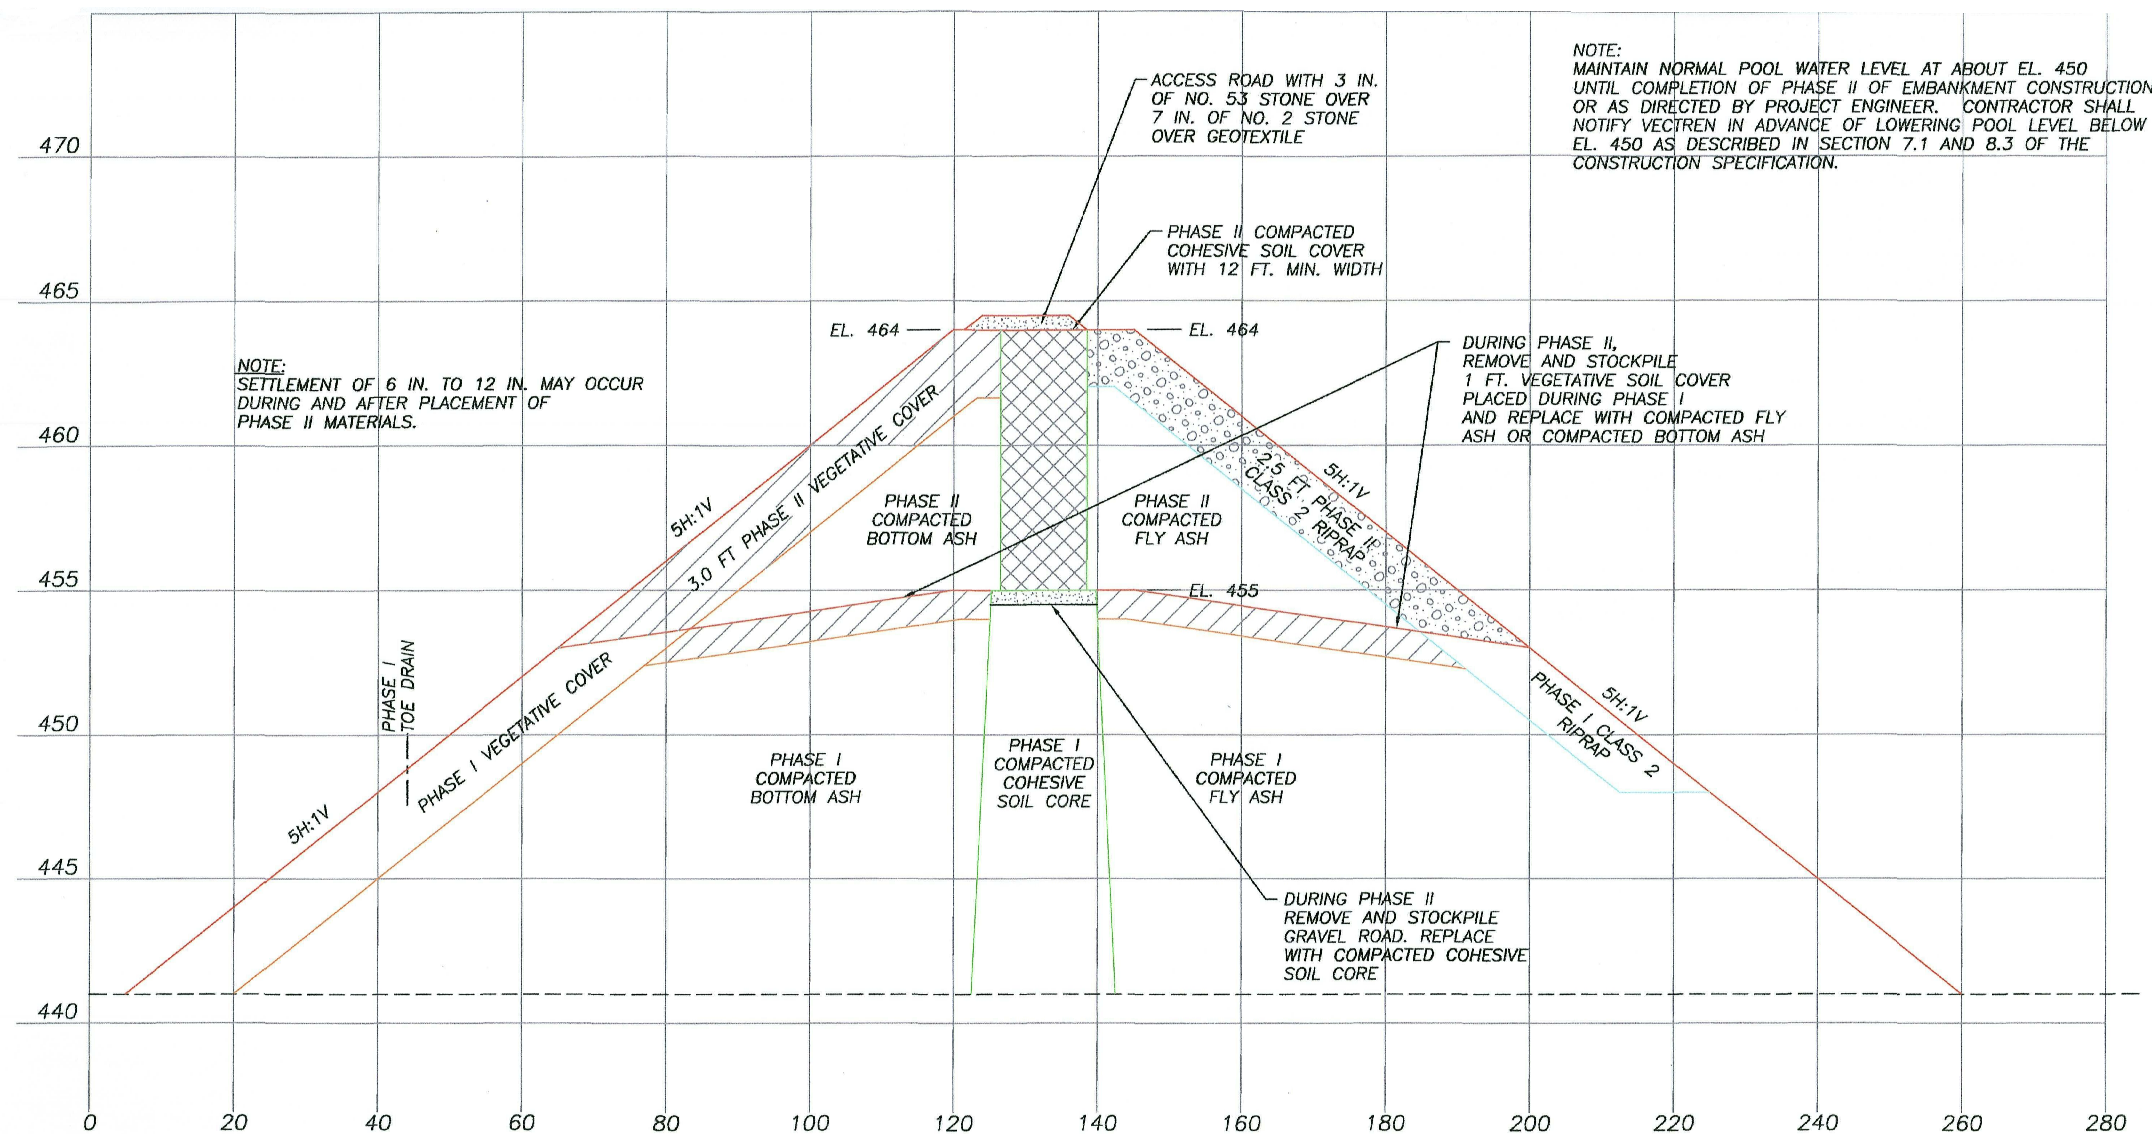
FIGURE 3

TYPICAL EMBANKMENT CROSS SECTION

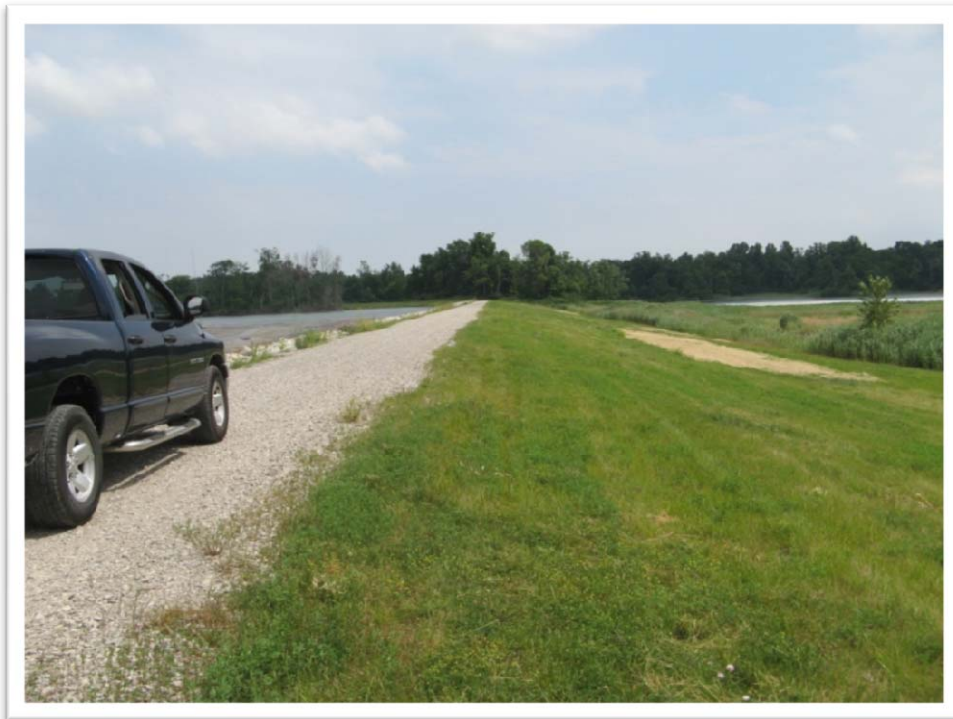
Upper Pond – The dam crest is lined with crushed stone and appeared to be in good condition. Fly ash from the generating station was discharging as a black-ish stream from a pipe on the embankment into the southwestern part of the pond. The bottom ash pipe adjacent to the fly ash discharge pipe was not flowing. The surface of the pond in the vicinity of the ash discharge pipes had a solidified black residue from the ash material. Influent from the fly ash line flows over the solidified material towards the principal spillway outlet in the southeast corner area of the pond.

Photo 1- Upper Ash Pond Dam Crest Looking South

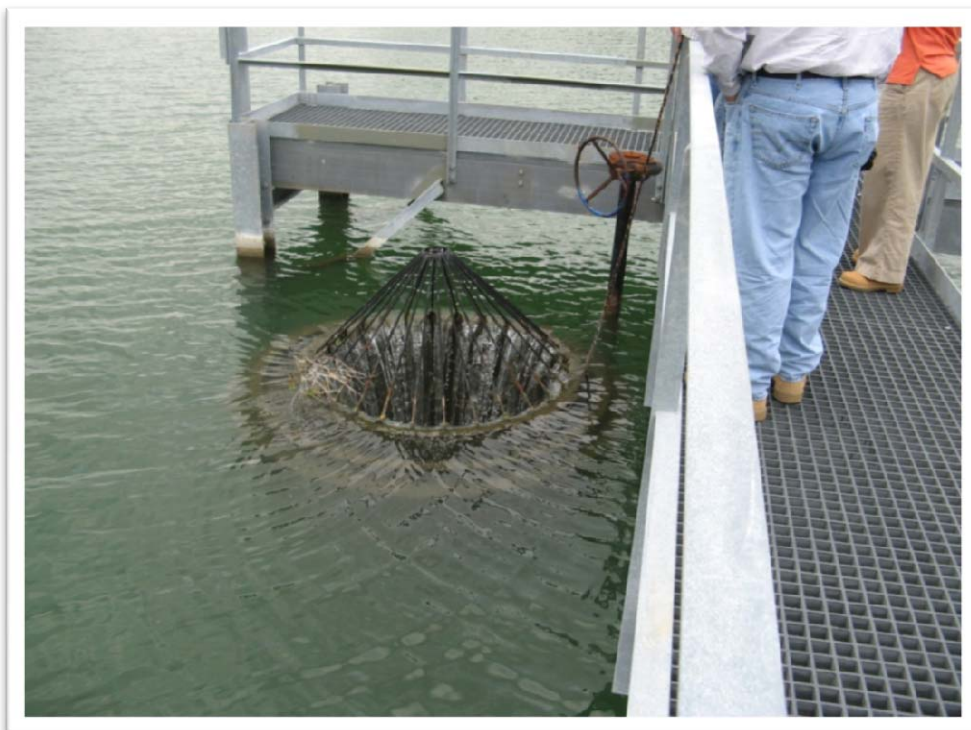
Spillway System - The principal spillway, which consists of a 60-inch diameter RCP drop inlet at El. 460 with a 24-inch diameter outlet pipe, was discharging at the time of inspection. The outlet pipe discharges into a rock-lined channel which leads to the Lower Pond. The emergency spillway is a 30-foot wide trapezoidal earth channel with 5H:1V side slopes and a crest elevation of 461.5. Both portions of the spillway system appeared to be in good condition; however, some overgrowth of vegetation was observed in the emergency spillway outlet channel.

2. Spillway System – The drop inlet principal spillway appears to be in good condition and functioning as designed. The trash rack for the drop inlet opening is somewhat smaller than typical spillway racks, but should be adequate for the limited amount of runoff experienced by the Upper Pond. The emergency spillway also appears to be in good condition, with a riprap cover that should adequately protect the outlet channel against erosion during heavy flows. Some overgrowth of vegetation is evident in the outlet channel, but should not significantly inhibit flow through the spillway.

Photo 2- Principal Spillway Drop Inlet

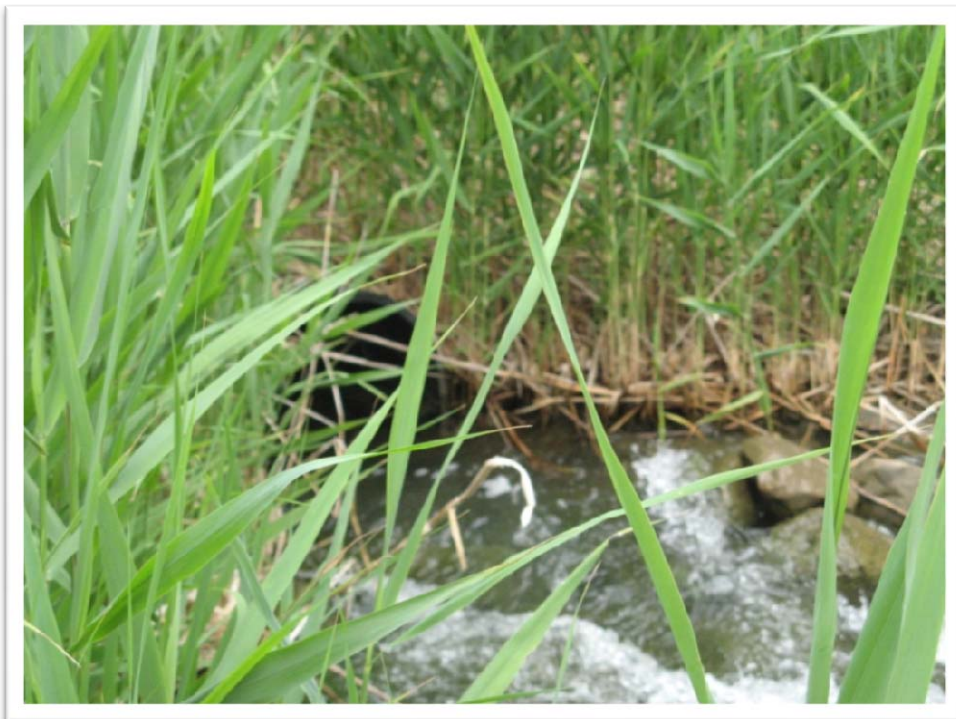
Photo 3- Principal Spillway Outlet

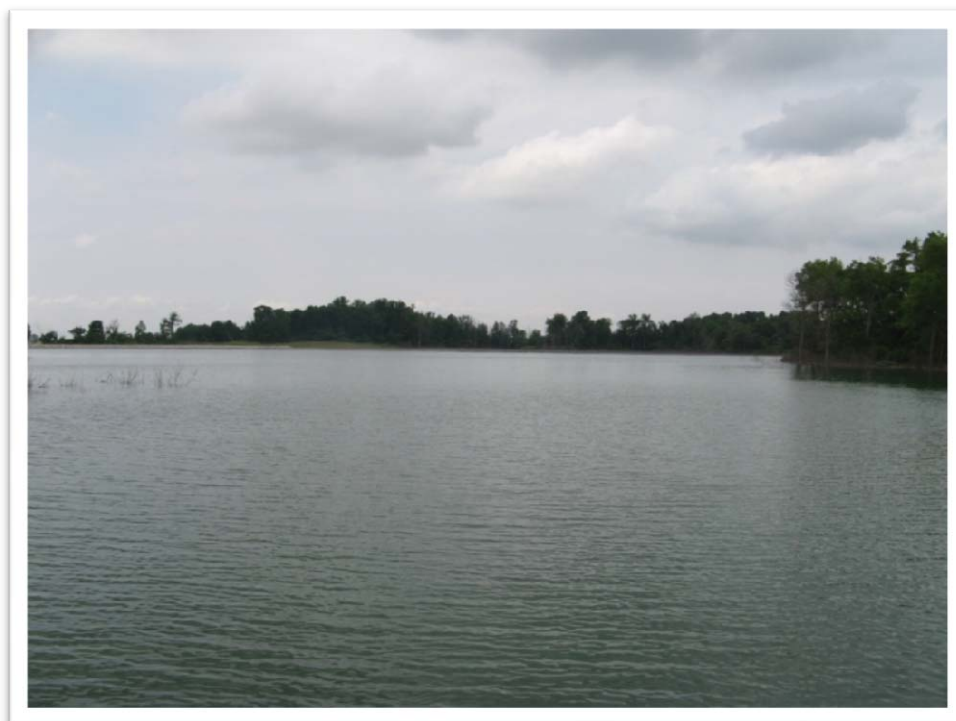
Photo 4- Upper Ash Pond Looking Northwest

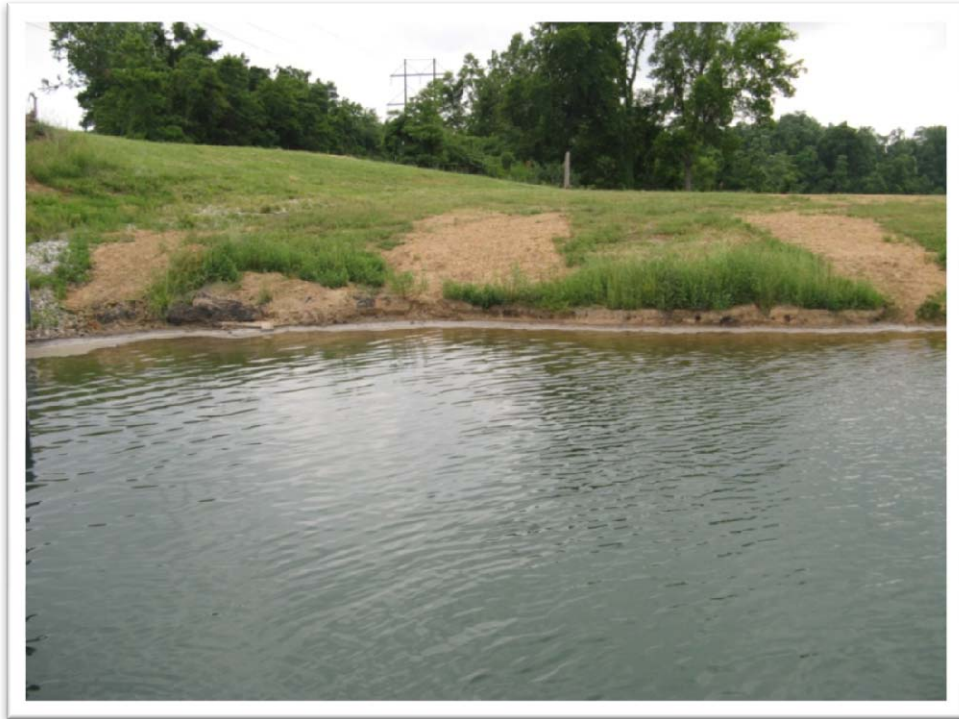
Earth Embankment - The crest and upstream embankment slope appear to be in generally good condition, with some repairs related to the ATC report recommendations noticeable. The upper portion of the slope is lined with riprap, which appears to be providing adequate erosion protection.

Photo 5- Upstream Embankment Looking West Near Principal Spillway. Note Repairs on Embankment

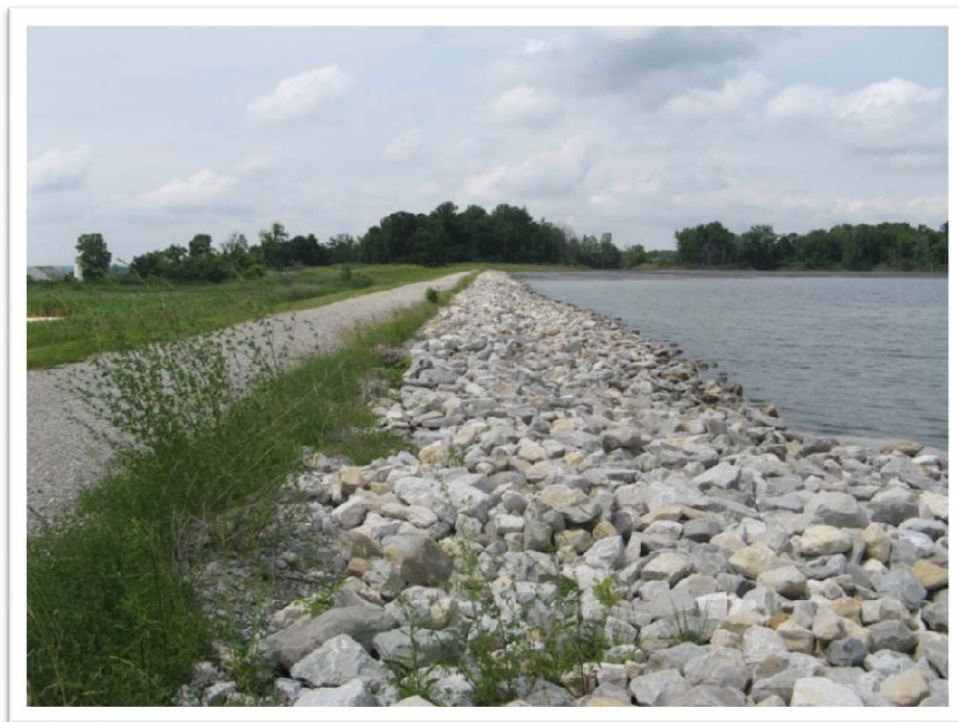
Photo 6- Dam Crest and Upstream Rip-Rapped Embankment Looking Northwest

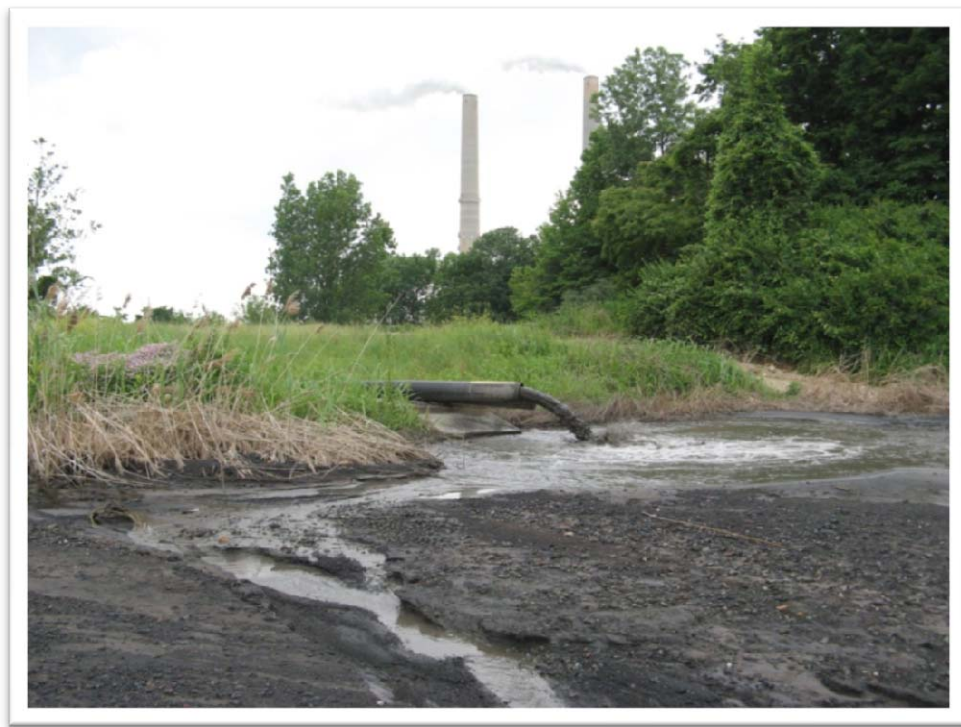
Photo 7- Southwest Area of Ash Pond with Fly Ash Discharge and Solidified Waste Material

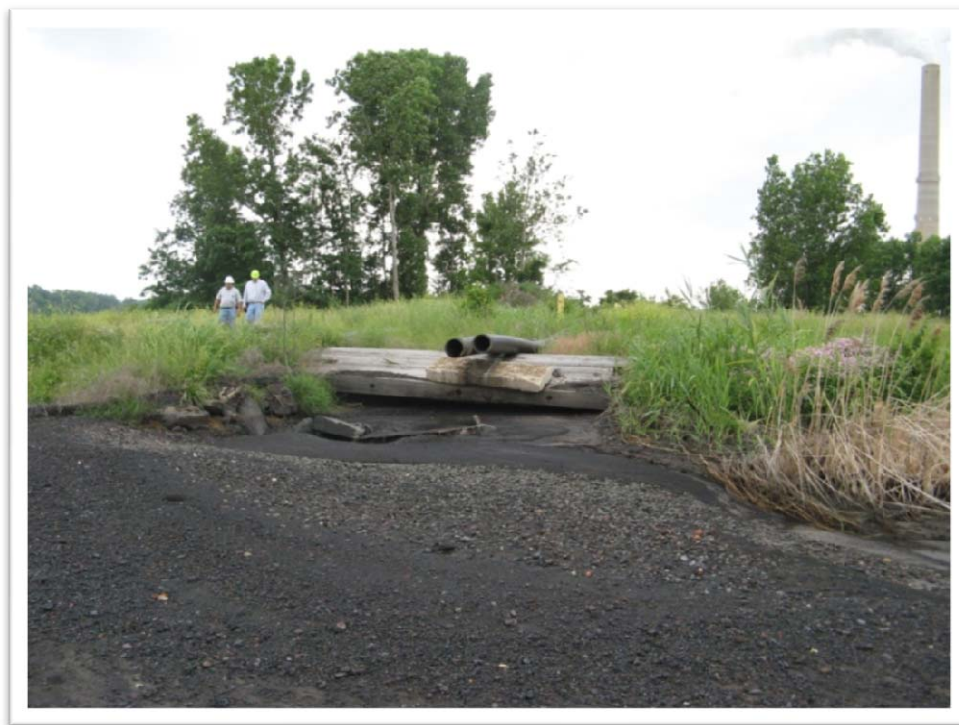
Photo 8- Southwest Area of Ash Pond with Bottom Ash Discharge Pipes and Solidified Waste Material

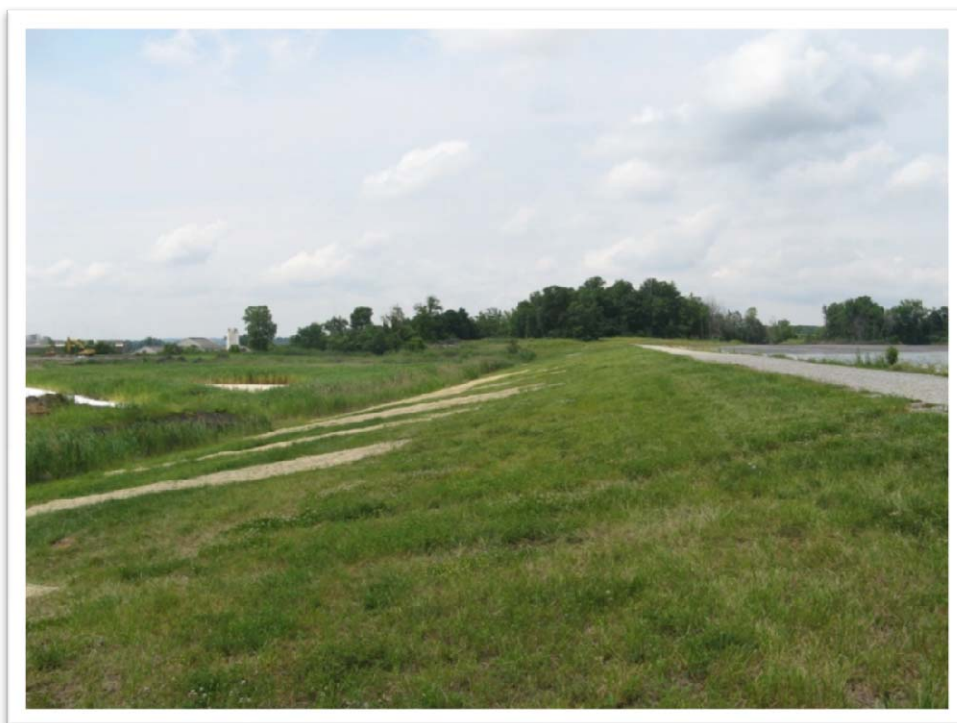
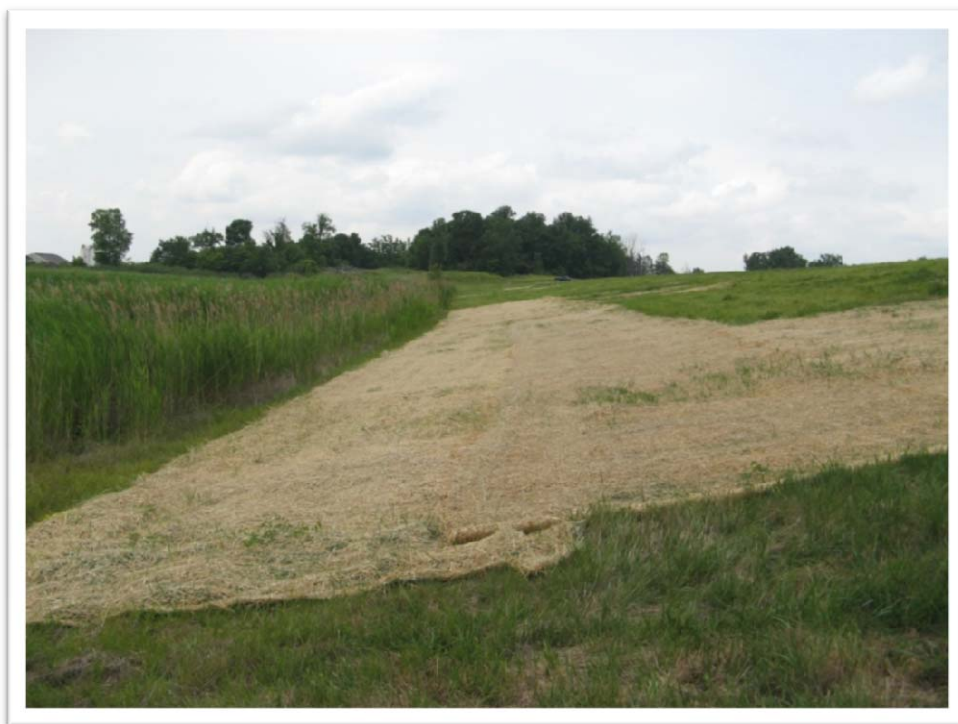
Downstream Slope - The downstream embankment slope appears to be in satisfactory condition, also with repairs related to the ATC report recommendations noticeable. Erosion gullies that had developed from storm runoff had been filled with earth, seeded and mulched; however, additional gullies were forming at the base of the straw mat component of the repair work. The downstream toe of the Upper Dam terminates at the edge of the Lower Pond, such that the toe is slightly submerged. The principal spillway outlet from the Upper Pond discharges into the eastern end of the Lower Pond and, at the time of inspection, flow was entering the Lower Pond from the Upper Pond. At one location, the scrubber blowdown outlet channel along the edge of the Lower Pond has caused some erosion of the channel edge in the general vicinity of the downstream toe of the Upper Dam.

- Continuing erosion of the downstream slope could lead to reduced stability of the embankment in the future. The cause of this condition should be investigated and further remedial action should be taken.

Photo 9- Downstream Embankment Area Looking Northwest. Note Repaired Areas

Photo 10- Downstream Embankment Area Looking Northwest. Note Repaired Areas

1. The effectiveness of the erosion repairs along the downstream slope of the dam should be evaluated once the grass vegetation has become adequately established in these areas. If the erosion persists, consideration should be given to use of better topsoil, placement of more erosion-resistant vegetation, regrading of the crest to promote more uniform runoff, use of turf reinforcement matting and/or placement of stone/rock along the lower portion of the slope.

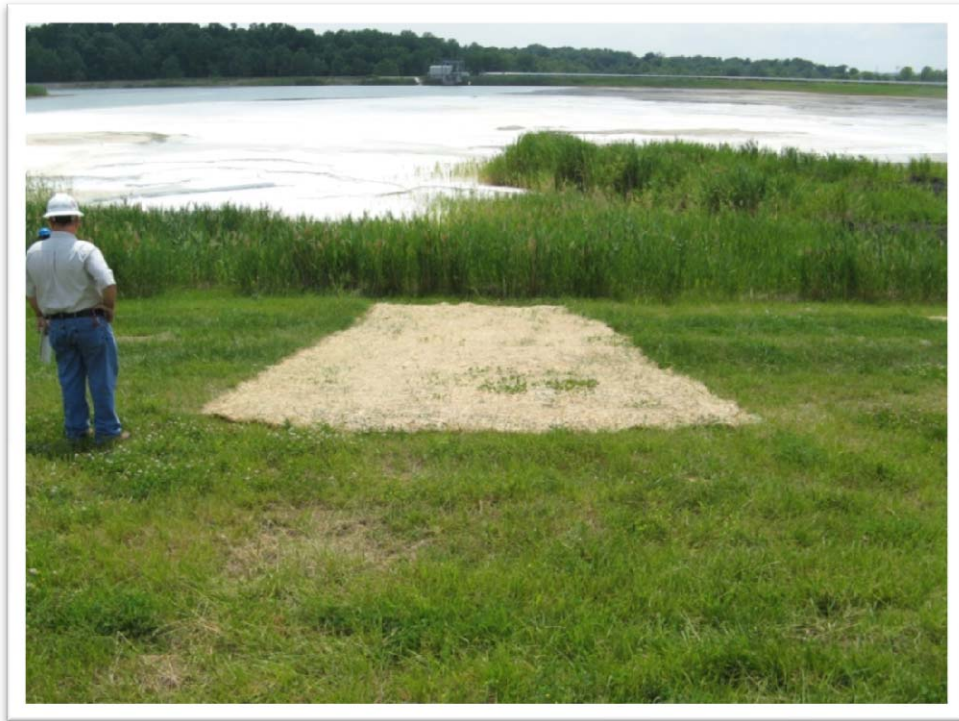
Photo 11- Downstream Embankment Area Looking South. Note Repaired Area and Lower Pond

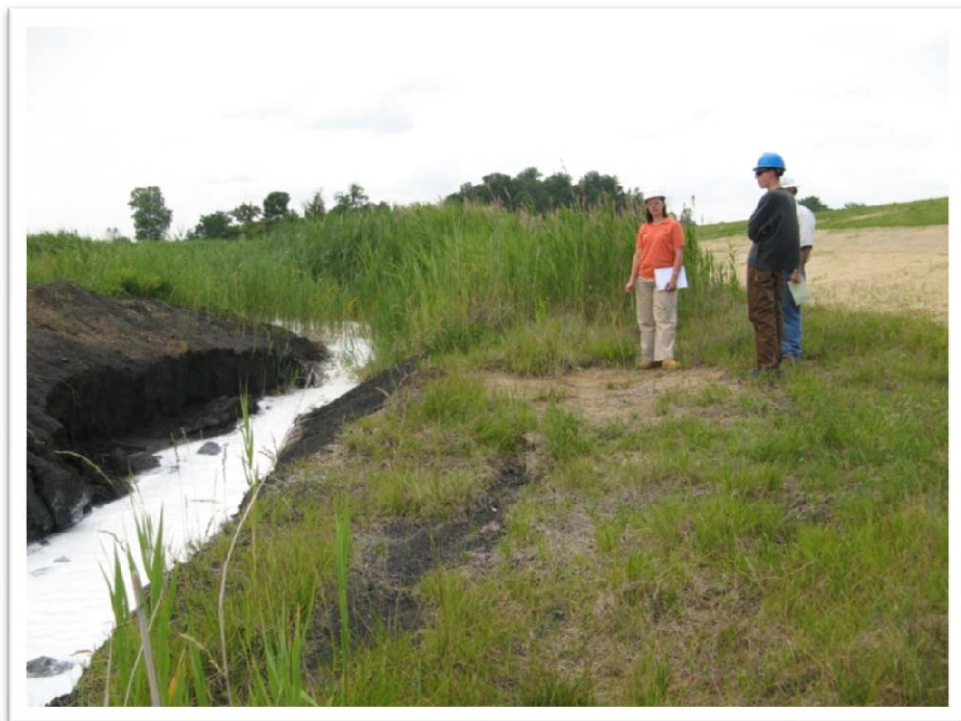
- Erosion of the scrubber blowdown outlet channel could eventually encroach on the downstream toe of the Upper Dam; this condition should be monitored.

Photo 12- Downstream Embankment Area Looking Northwest. Note repaired Area and Lower Pond with Channel for White-ish Scrubber Blowdown at Toe of Upper Dam Embankment

The erosion along the edge of the scrubber blowdown outlet channel should be monitored during future inspections to verify that the erosion does not impact the downstream toe of the Upper Dam.

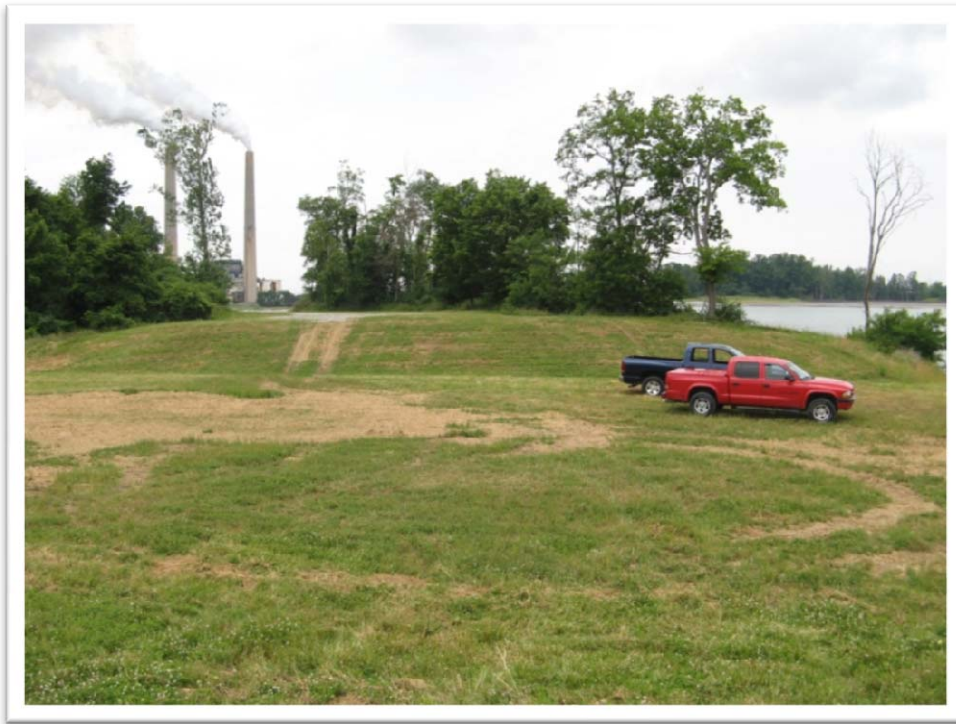
Photo 13- Crest of Upper Ash Pond Dam at Emergency Spillway Looking Northwest

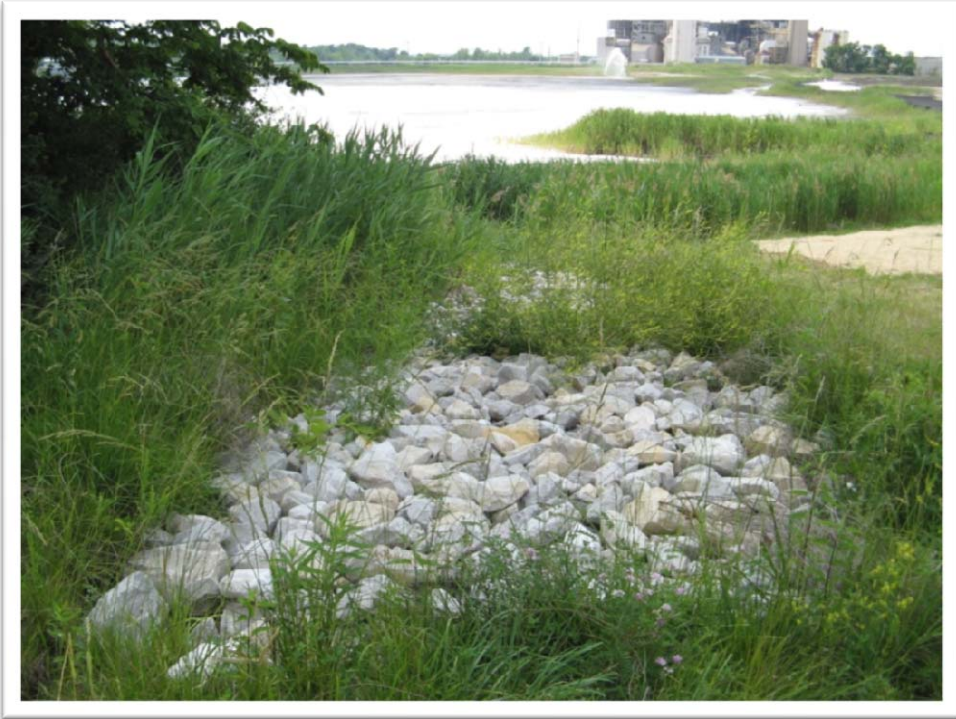
Photo 14- Emergency Spillway Looking West. Note Vegetation Growth in Spillway

3. The vegetation in the emergency spillway outlet channel should be removed to prevent further overgrowth and possible future blockage of the outflow path.
